Windows

Preservation Guidelines: Windows

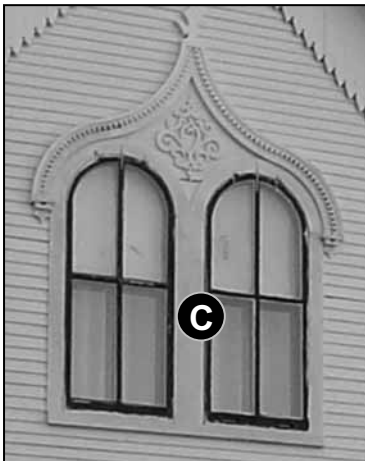
Fig. 5-18: 125 Jefferson St. Wood storm windows match the unique window design.

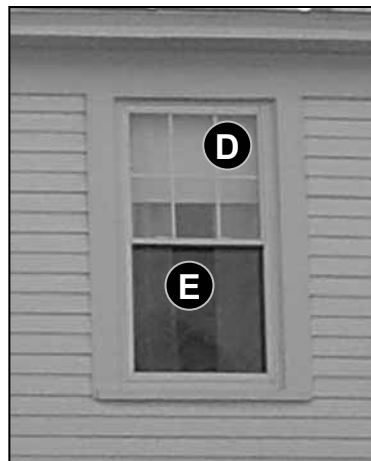
Fig. 5-19: 213 Washington St. The storm windows are recessed inside the window trim, and are designed to blend into the overall design.

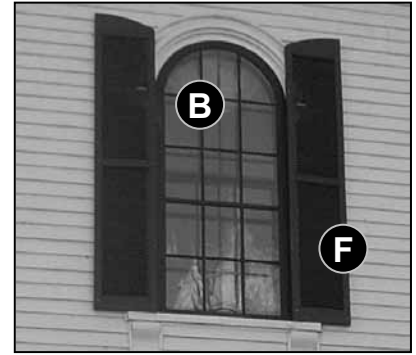
Fig. 5-16: 213 Main St. Custom wood storm windows and working shutters match the design and blend nicely with the historic architecture.

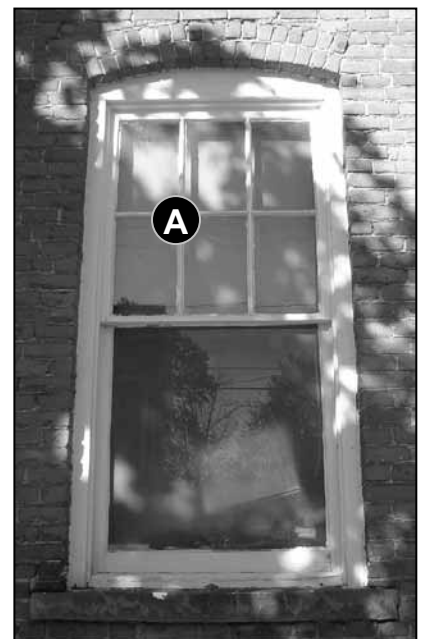
Fig. 5-17: 120 Benmont Ave. It is best to try to repair existing historic windows before replacing them altogether.

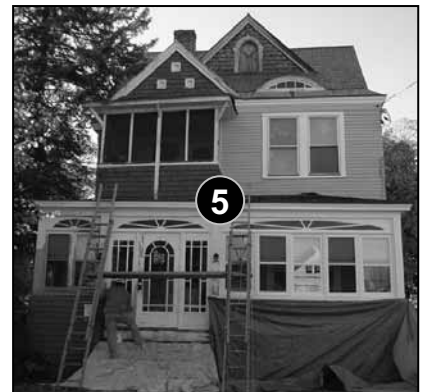
Fig. 5-20: 217 Washington St. Many different window types and sizes can make a façade appear confusing.

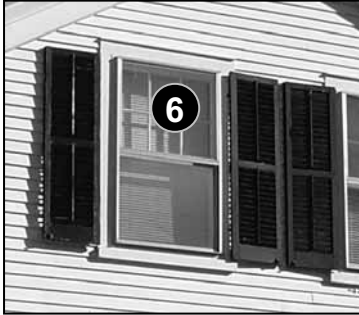
Fig. 5-21: 102 Jefferson St. Bare metal storm windows are mounted onto and covering the window trim, which is not ideal. Also, shutters are not consistently mounted to the windows.

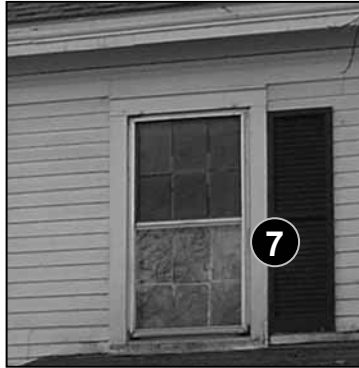
Fig. 5-22: 105 Holden St. Window shutters should be used realistically and consistently on a façade. The imitation window shutters like the one shown here are often seen used on only one side of a window, or on alternate sides of a pair of windows. Such installations are not historically accurate.

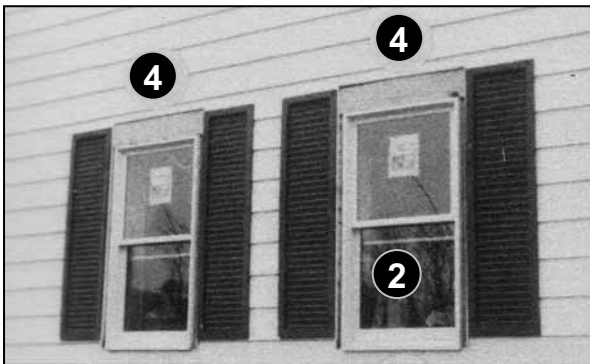
Fig. 5-23: The original historic windows have been removed in this picture and replaced with smaller vinyl clad windows. [Date unknown.]

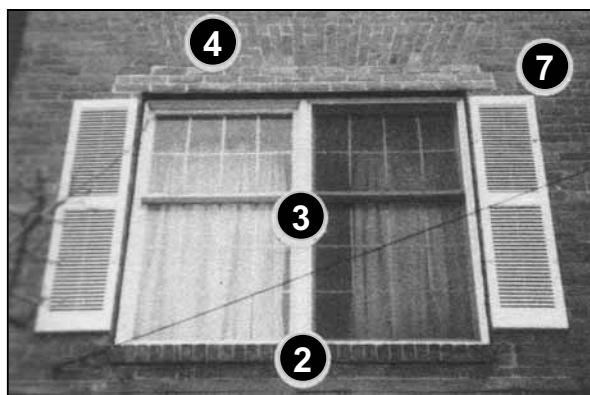
Fig. 5-24: The imitation window shutters like the ones shown here do not make any sense on either side of this large window opening since they would not be able to cover the window. Also, the original arched top of the window has been filled-in and replaced with a straight metal lintel. [Date unknown.]

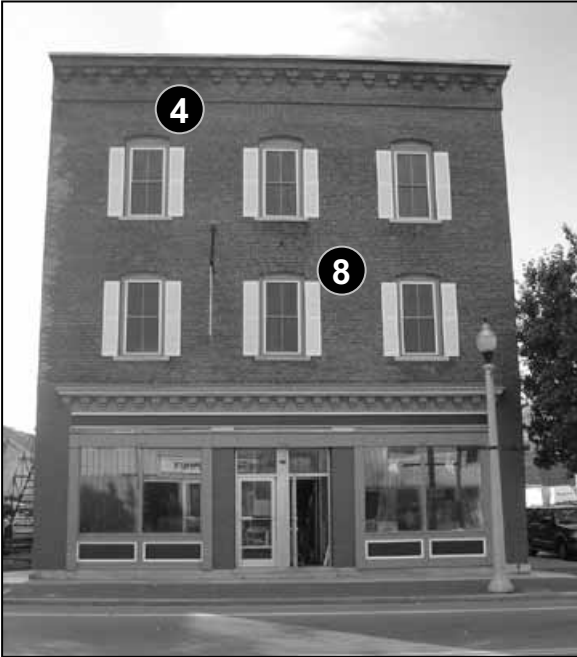
Fig. 5-25: 198 North St. The original windows have been removed and replaced with smaller ones without the arched top. The original windows of this building never had shutters, yet new vinyl ones have been added here. This does not match the original design, and doesn't even match the windows on the side of the building, as shown in Fig. 5-26.

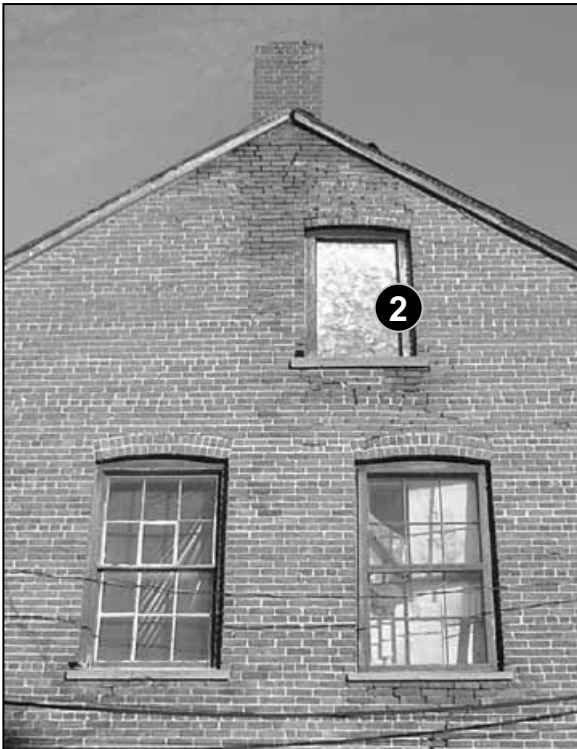
Fig. 5-28: 512 Main St. Windows that are no longer used should not be boarded up or filled in on the outside. Instead, the wall can be in-filled on the inside, leaving the existing window to remain on the outside.

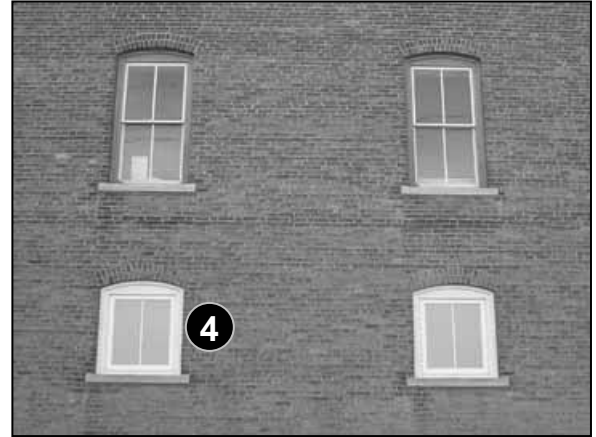
Fig. 5-26: 198 North St. The original arched top windows have been replaced with smaller, flat-top windows, and don't match from the second to the third floor.

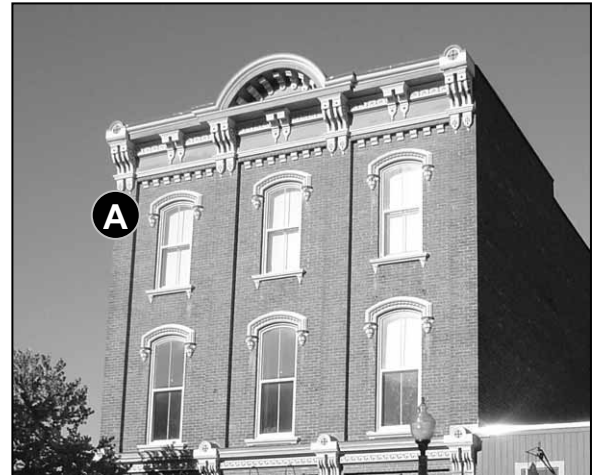
Fig. 5-27: 332 Main St. The original arched top windows have been maintained.

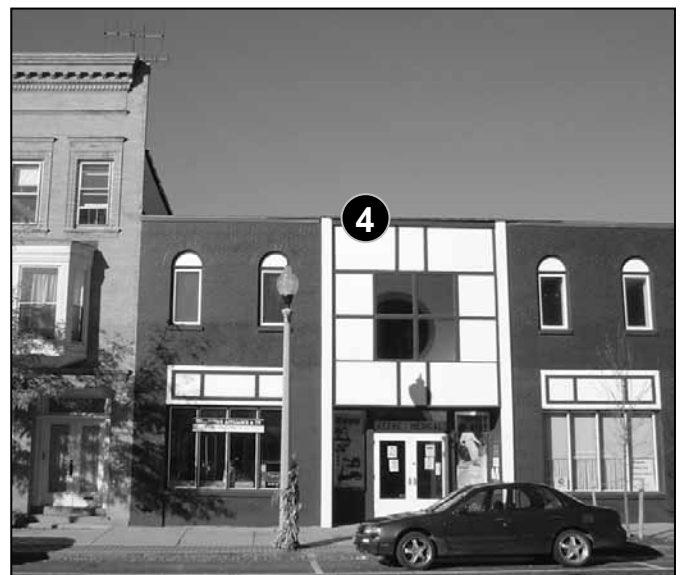
Fig. 5-29: 532 Main St. The original building façade here has been replaced with a large, post-modern window in the center which is inconsistent with the building and its surroundings.
