### Porches and Stairs

### Basic Guideline

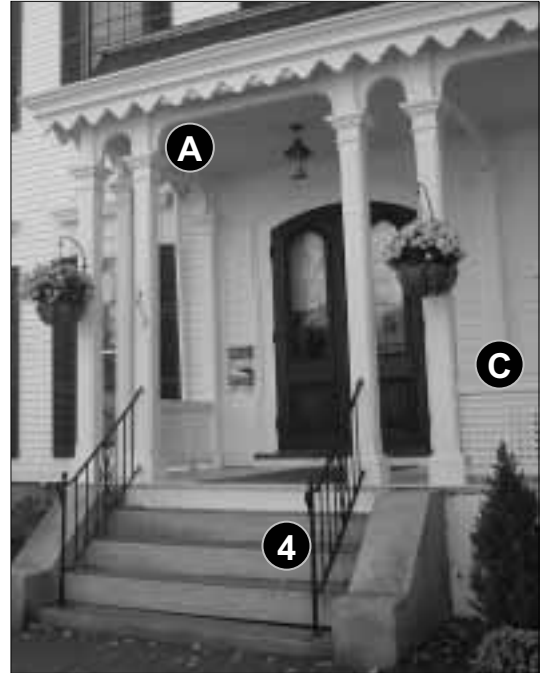
Fig. 5-1: 213 Main St. The ornamentation has been retained along the eaves, columns and porch railings, but the stair railings have been replaced with wrought iron.

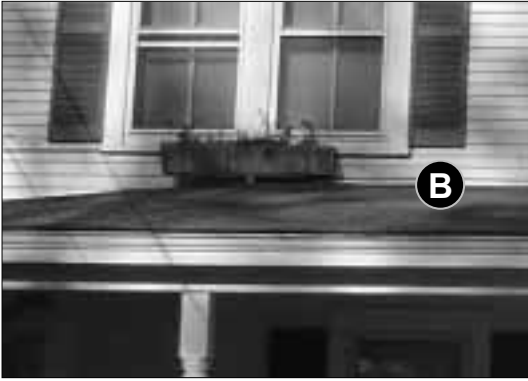
Fig. 5-3: 206 Main St. Porch roofs should be flashed properly and kept at least 10" below any windows to help prevent snow and water build-up at the window sill.

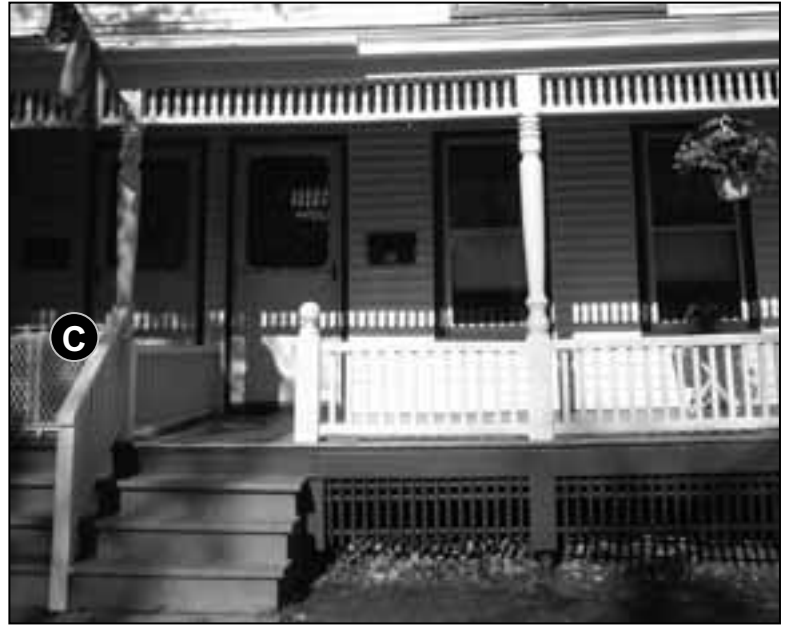
Fig. 5-4: 202 Main St. The front steps and railings up to this porch are similar to the style and character of the porch overall, and are painted to match. The underside of the porch is concealed with grillwork which allows the structure underneath to breathe.

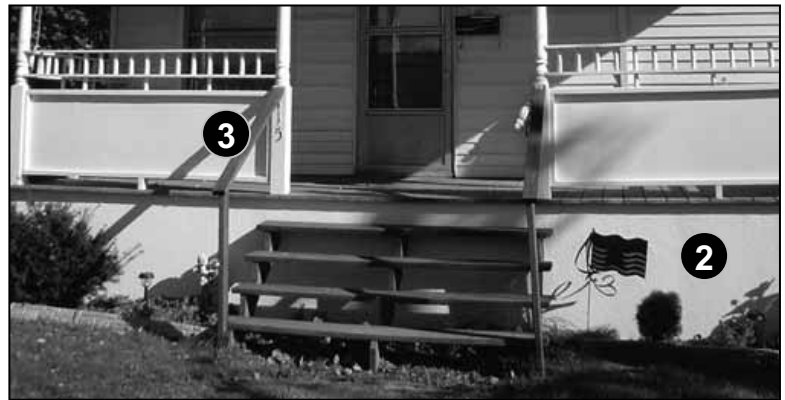
Fig. 5-6: 115 McKinley St. The front steps and railings up to this porch do not match the original porch design, and are instead constructed of standard framing lumber. The porch railings have themselves been replaced with blank wood panels which changes the scale of the facade. The underside of this porch has been completely enclosed as well, and likely does not provide enough ventilation to prevent moisture buildup and rot.

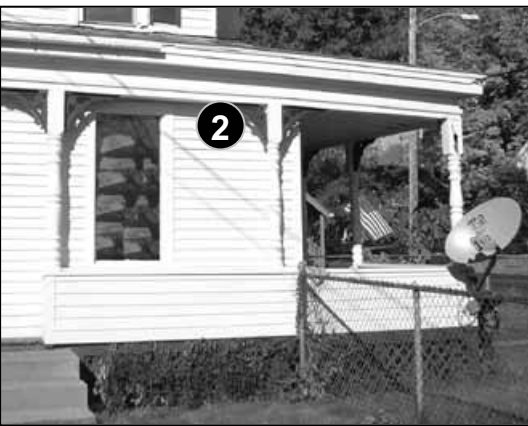
Fig. 5-7: 138 River St. The front porch of this structure has been partially filled-in with an addition.
