Site and Landscaping

Preservation Guidelines: Site & Landscaping

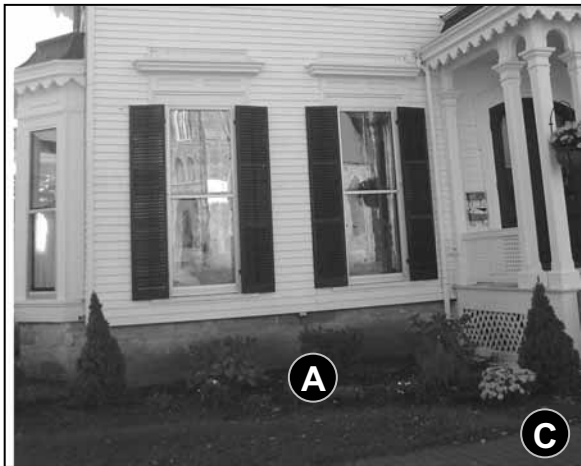
Fig. 5-57: 213 Main St. Small shrubs along the foundation of the building still allow sunlight, ventilation and access for maintenance.

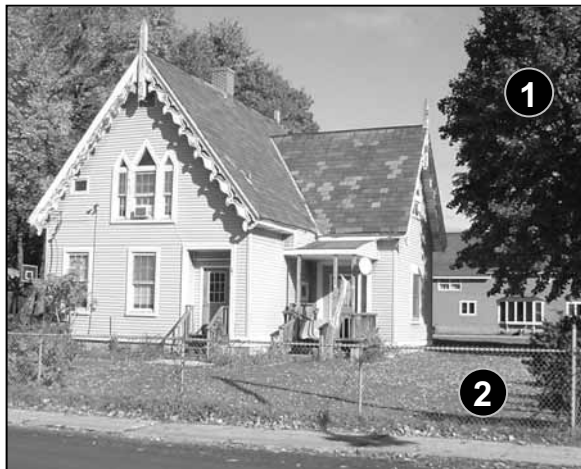
Fig. 5-59: 207 Depot St. The chain link fence here does not match the character of the house. A wooden picket fence would be more appropriate.

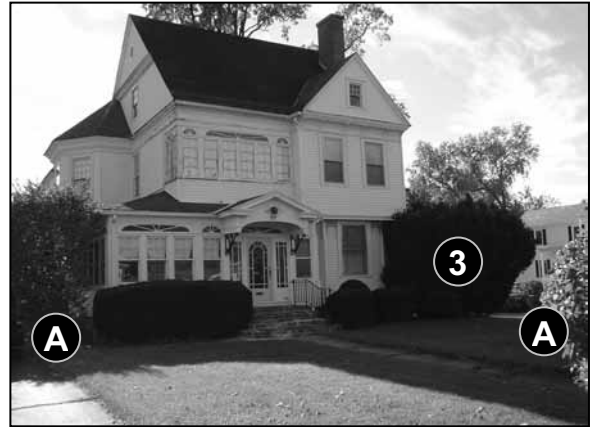
Fig. 5-56: 217 Main St. The large bush to the right of this house has overgrown and may cause moisture damage to the exterior.

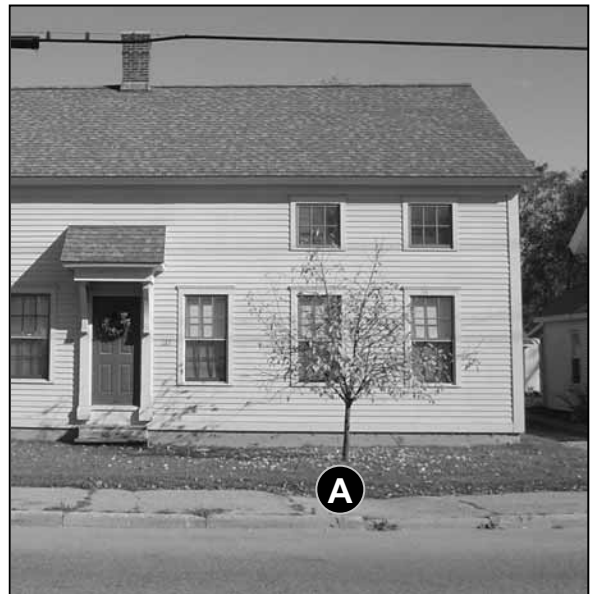
Fig. 5-58: 137 Benmont Ave. When larger trees cannot be saved, new ones should be planted to replace them.

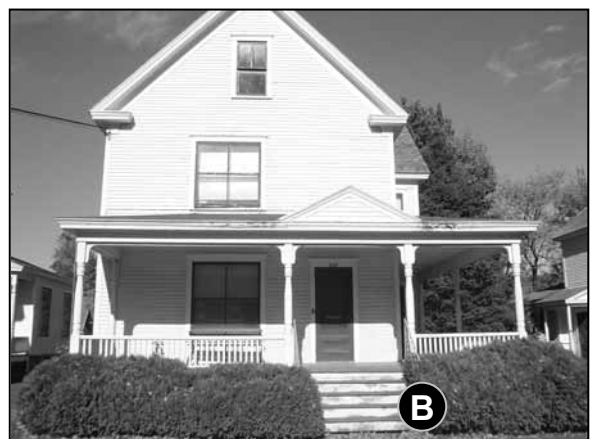
Fig. 5-60: 204 Main St. These hedges have been trimmed to keep from overwhelming the porch, but could be trimmed more in the back to prevent water damage to the porch.

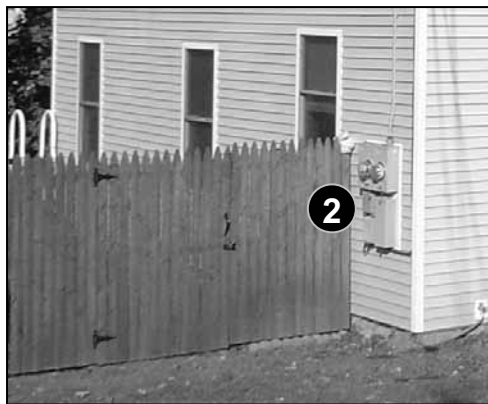
Fig. 5-63: Corner of Weeks & Jefferson. Although the electric meter has to be accessible, it doesn't need to be so visible.

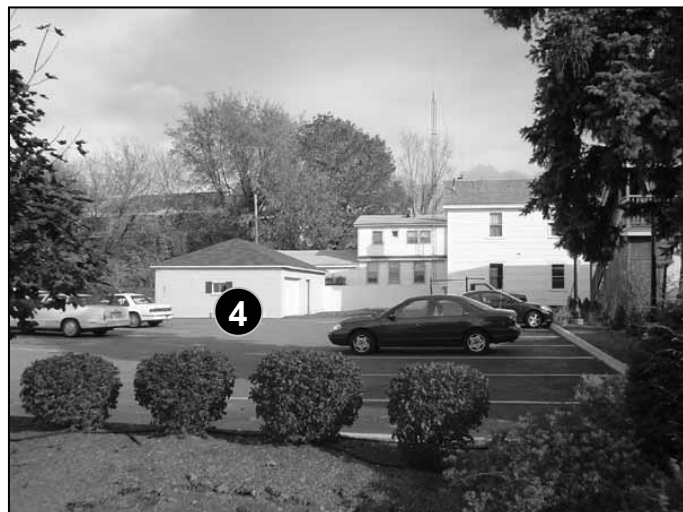
Fig. 5-64: North St. This large parking lot is clearly visible from the sidewalk, and should be screened more properly.
