# Preservation Guidelines: Storefronts

## Storefronts

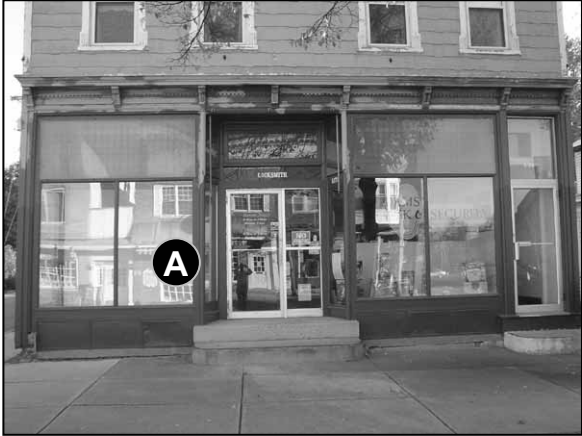
Fig. 5-79: 497 Main St. Original storefront still exists.

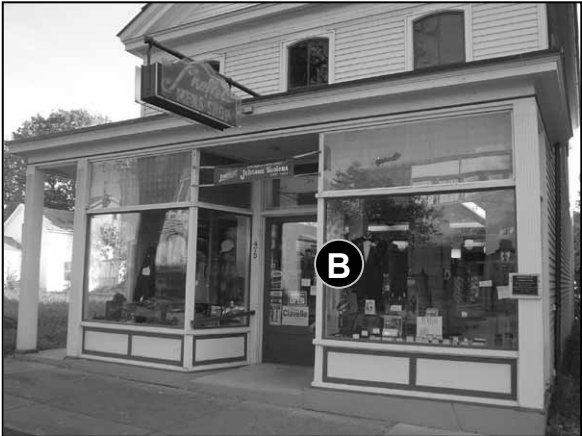
Fig. 5-80: 475 Main St. Original storefront design has been preserved.

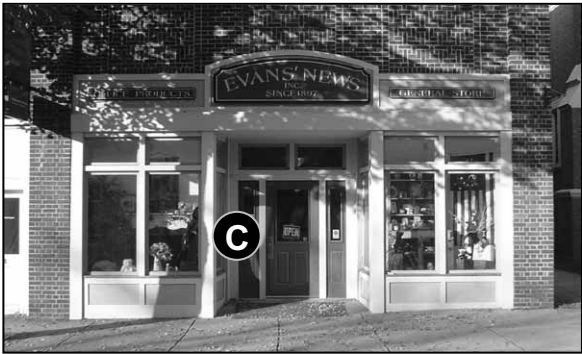
Fig. 5-81: 432 Main St. Compatible new storefront.

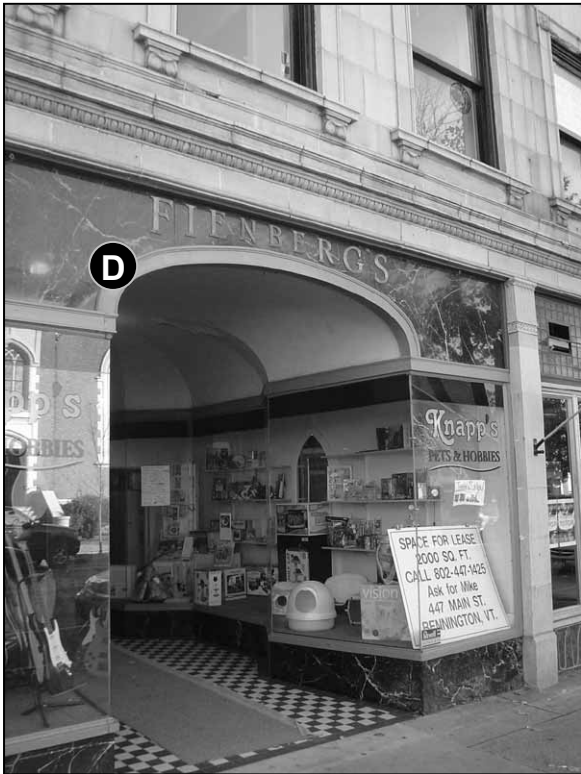
Fig. 5-82: 447 Main St. Historic storefront and sign have been preserved even though the business has changed.

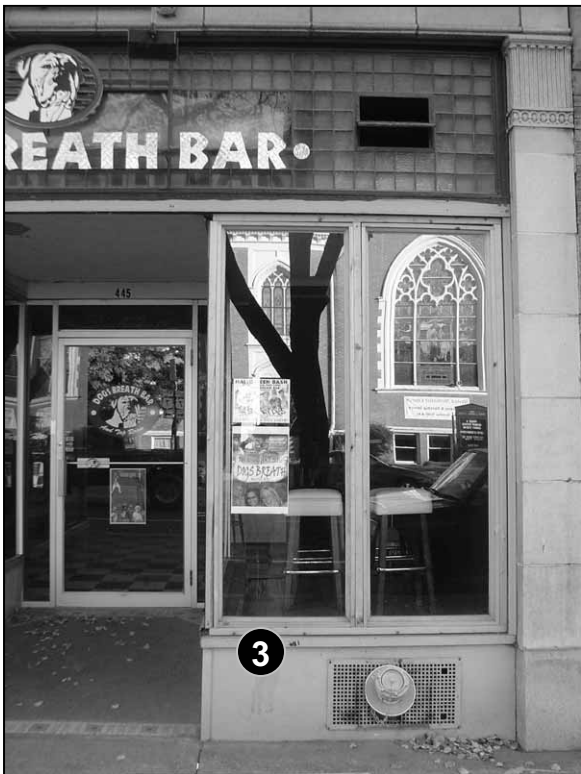
Fig. 5-83: 449 Main St. Bare lumber framing for the storefront windows is not in keeping with historic designs.

- 1** Removing historic storefront features.
- 2** Constructing storefronts whose materials and design is not in keeping with historic character.
- 3** Especially avoid such materials as brick, rough-sawn wood, stucco, artificial stone and flat sheet metal where they have no relationship to a building's historic design.

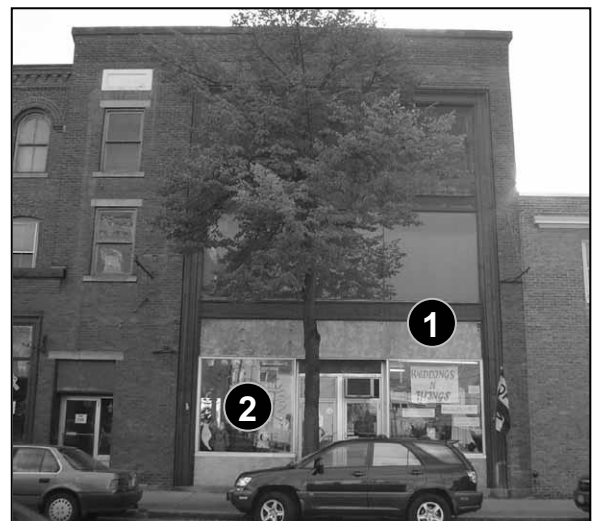
Fig. 5-84: 337 Main St. Original storefront has been replaced with bare aluminum framed picture windows and blank, unfinished panels.
